# **Alcor A-3629**

## **Case Report**

**Linda Chamberlain, Co-Founder and  
Director of Special Projects,  
Alcor Life Extension Foundation**

**March – 2024**

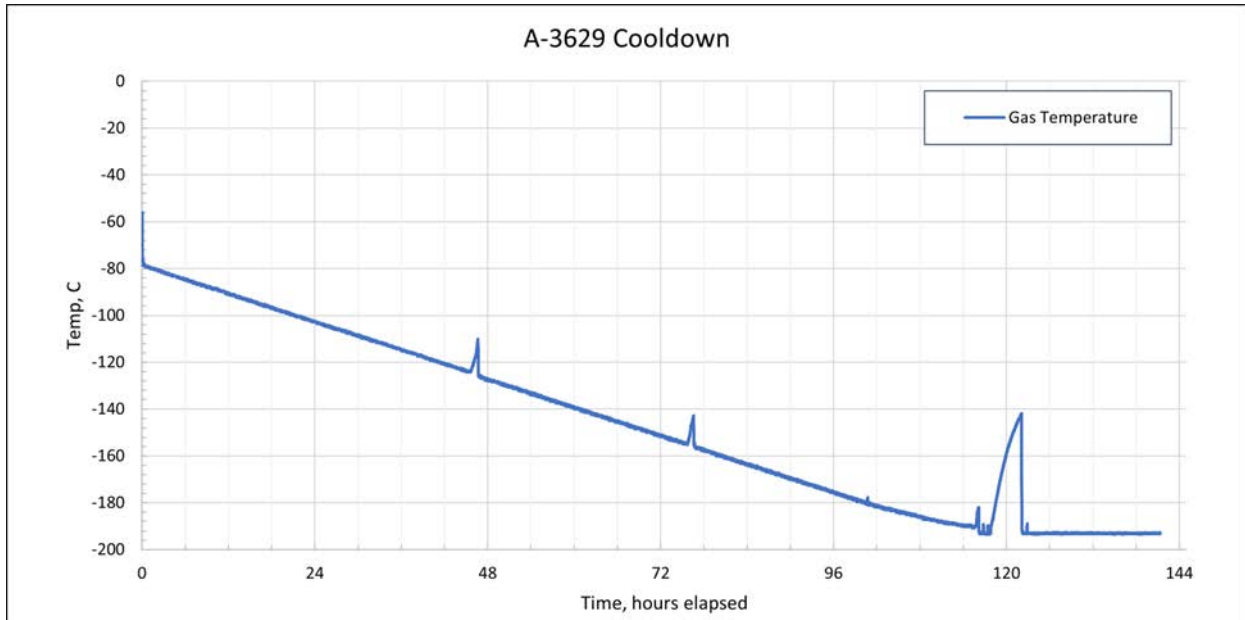
## 6. Cooldown Graph and CT Scans

Short temperature spikes in the below cooldown graph correspond to times when the 200L LN2 supply dewars were being swapped out. The largest spike occurred due to the primary valve failing. This was resolved by replacing the valve.

The LN2 valve failed at 07:30 hrs on T+5 days. The valve was replaced, and cooldown was resumed on T+5 days at 11:00 hrs. Other than the time required to replace the valve, the patient was maintained at a stable temperature and no deleterious effects occurred as a result of valve failure.
